# **Hydrogeologic Investigation of Rodale Manufacturing Site Emmaus, Pennsylvania**

November 1989

PHASE II REPORT

HYDROGEOLOGIC INVESTIGATION OF THE  
RODALE MANUFACTURING SITE, EMMAUS PENNSYLVANIA

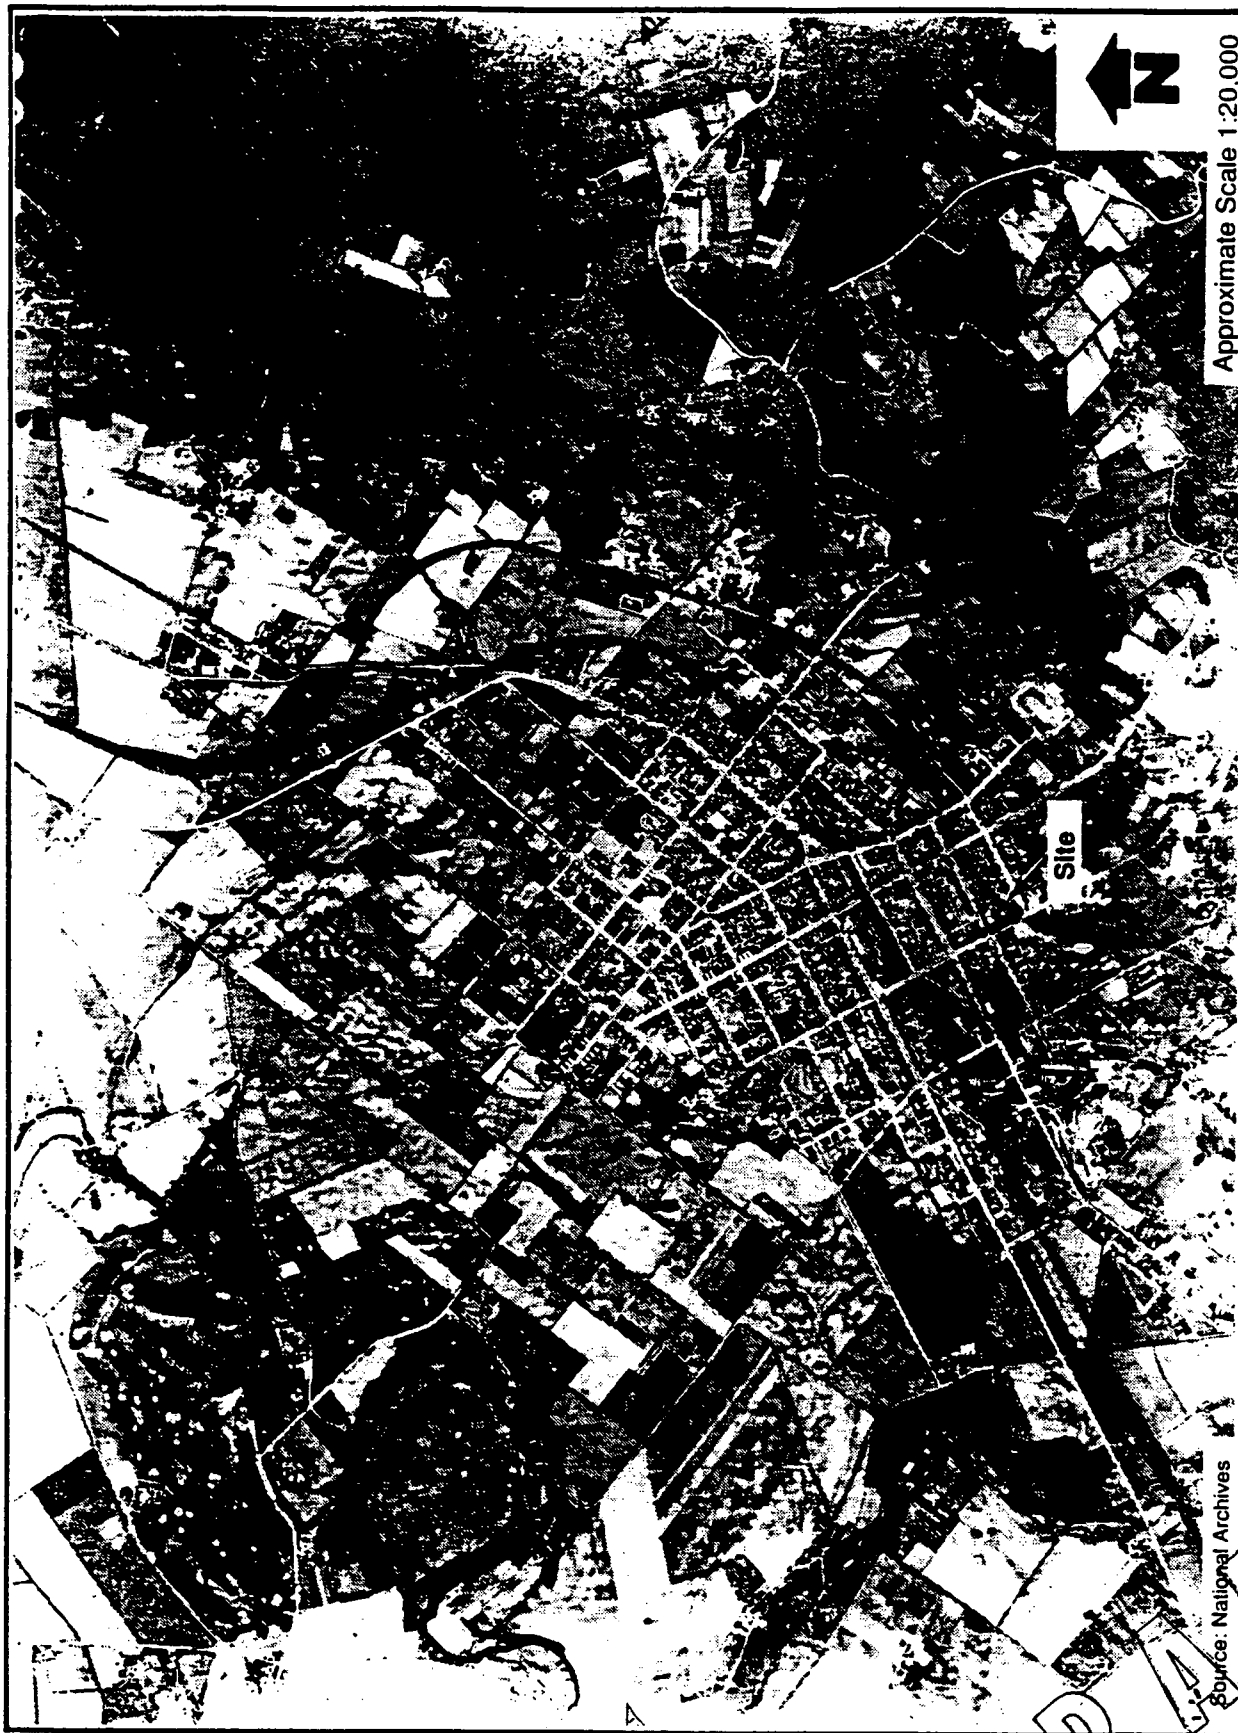
1939 AERIAL PHOTOGRAPH

The 1939 photographs show two areas of land disturbances that are not apparent on the subsequent photographs. One area is near Sixth and Harrison Streets. Because of the small scale and the quality of the photographs, it is unclear what activity occurred at this location; it may have been an old brick operation that existed in this area (Reiss, personal communications, 1989).

The other area located to the east of the intersection of Tenth and Broad Streets appears to have been a quarry that was subsequently filled. Currently, several industries are located in this area. The fill material is unknown.
